NASA TN D-6979

APOLLO COMMAND MODULE LAND-IMPACT TESTS

by J. E. McCullough and J. F. Lands, Jr.

Manned Spacecraft Center

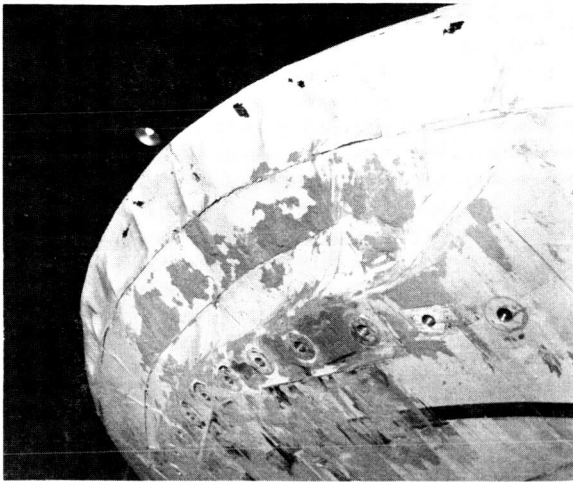
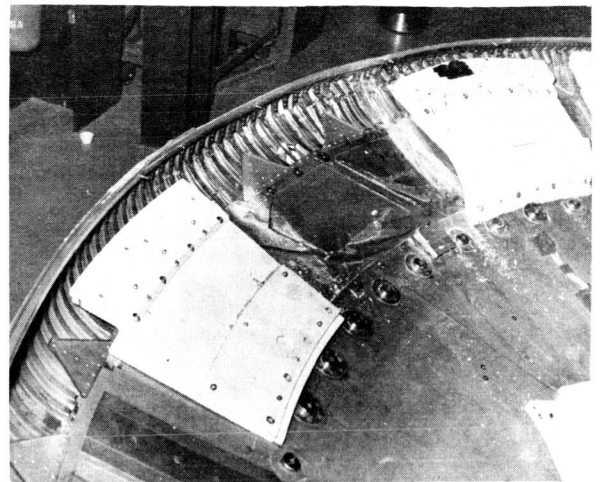
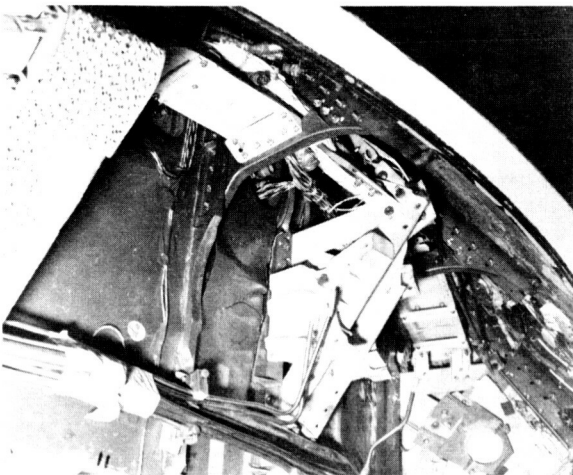
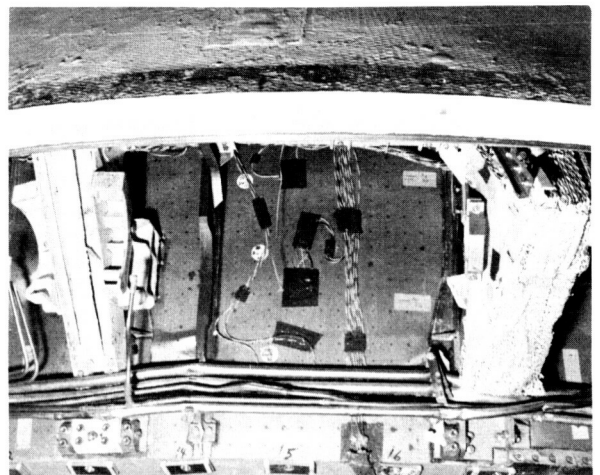
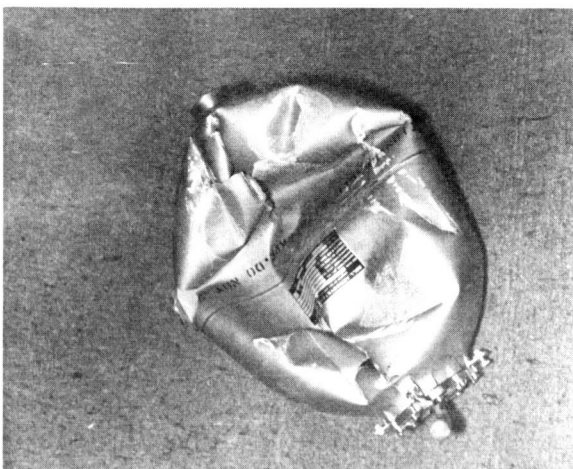
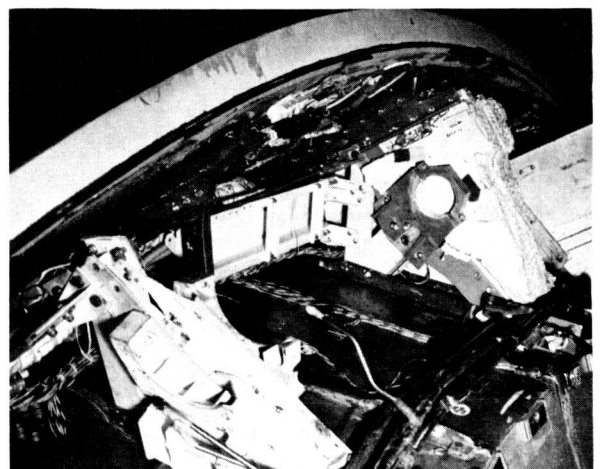
Figure 25. - Impact damage to CM-009 in test 31.

Damage to spacecraft structures caused by 0° roll landings was less extensive than had been expected. The damage was limited largely to the +Z area of the aft bulkhead, heat shield, and crew-compartment sidewall. The aft heat shield was crushed into the aft equipment bay, causing damage to the RCS oxidizer tanks and related equipment installed in that area. Frames and cores were crushed, fractured, and debonded from the sidewall throughout a sector of approximately 60° . Several face-sheet cracks and separations occurred in the honeycomb core of the crew-compartment sidewall. These openings could admit toxic fumes from the ruptured RCS tanks into the crew compartment. Apparently, no other failures occurred either in primary structure or in secondary equipment. The primary damage sustained during the impact test of CM-009 (typical of the 0° roll landing damage) is shown in figure 25.

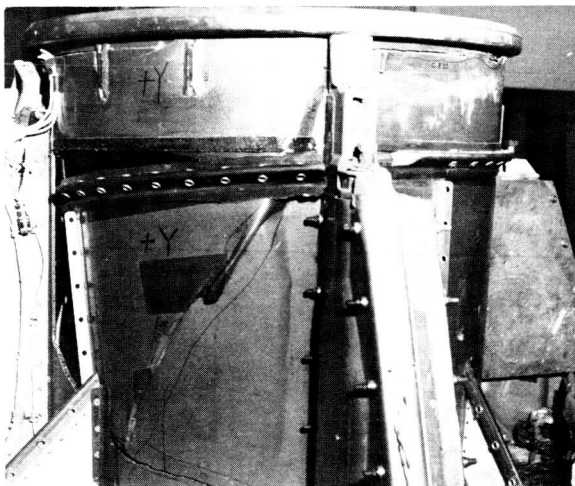
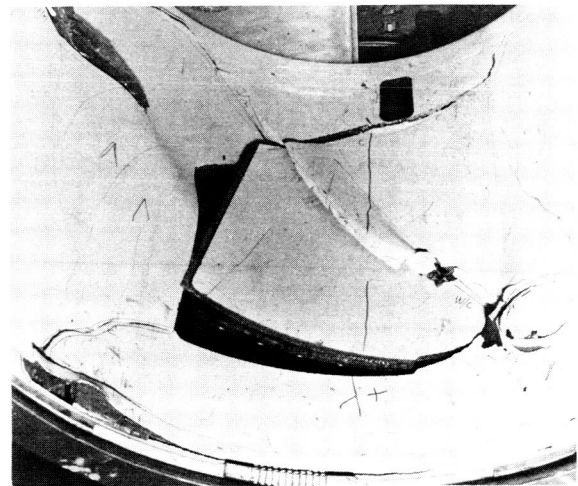
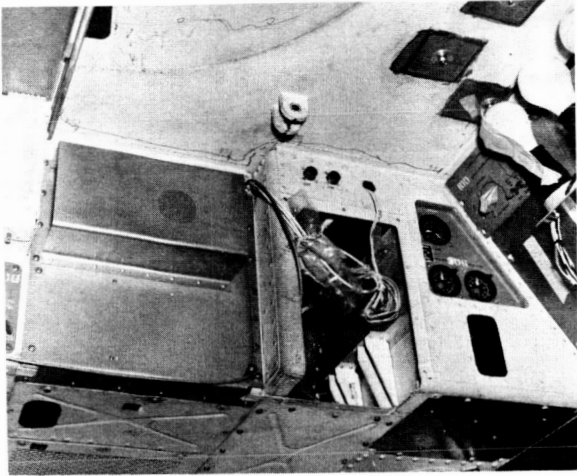
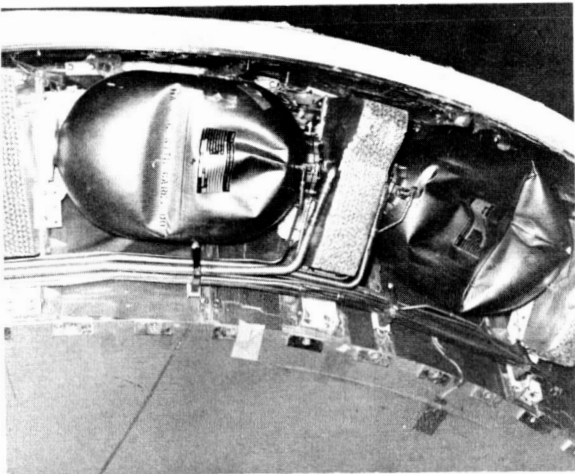
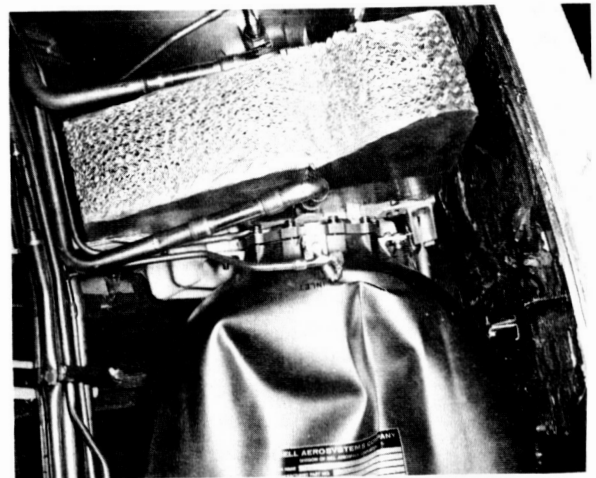
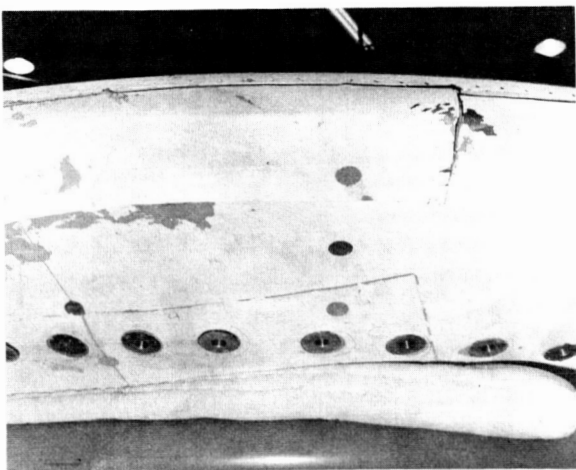
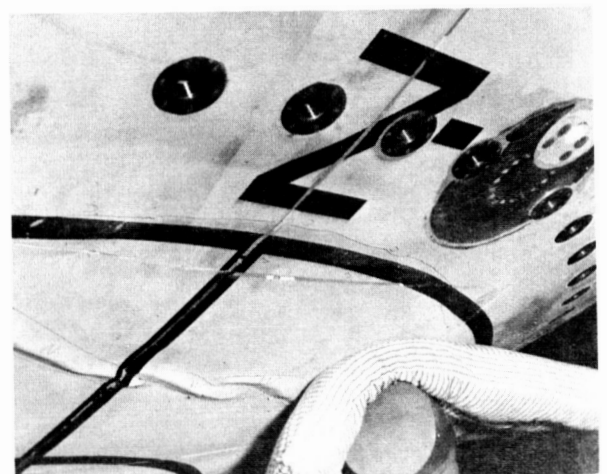
Figure 29. - Impact damage to CM-008.

Conditions were selected for the test of CM-008 to assess the damage to the upper deck and docking tunnel should the second impact of a land landing occur on this area. The test conditions to achieve such an attitude at second impact included a roll of 180° , a pitch of -27.5° , and a horizontal velocity at initial impact of 25 fps. The kinematics of the test of CM-008 are shown in the photographic sequence of figure 28. The upper deck, the docking tunnel, and the +Z sidewall of the crew compartment were damaged extensively (fig. 29). Many fractures occurred in the structures of the docking tunnel and upper deck, and extensive debonding of the main-display-panel support occurred. However, all damaged members remained attached to the structure of the test vehicle and did not present a significant crew hazard. The aft bulkhead was buckled approximately 6 to 8 inches into the crew compartment by the aft heat shield, and the crew-compartment sidewall was cracked completely through its core on the +Z side. The initial impact conditions for test 63 (second test of CM-009) were selected to determine the effects of a secondary impact on the +Z sidewall.

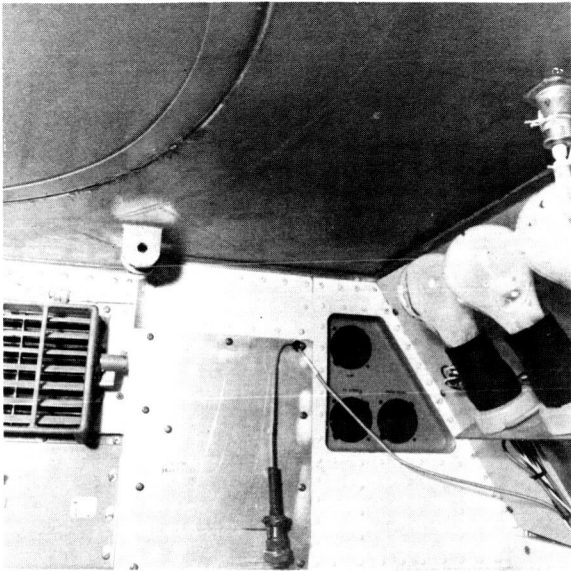
(a)

Although the docking tunnel contacted the impact surface on the +Z sector, the loading was light and no damage occurred to the tunnel. Debonding occurred between the forward bulkhead and the sidewall on the +Z side (fig. 31(a)), but no debonding occurred on the main display console.

The crew-compartment sidewall between stations $X_c = 42.0$ and $X_c = 81.5$ on the +Z side was crushed inward by the crew-compartment heat shield (fig. 31(b)). Several large cracks occurred through the +Z sector of the sidewall behind the lower equipment bay (fig. 31(c)), and the entire lower equipment bay was debonded from the

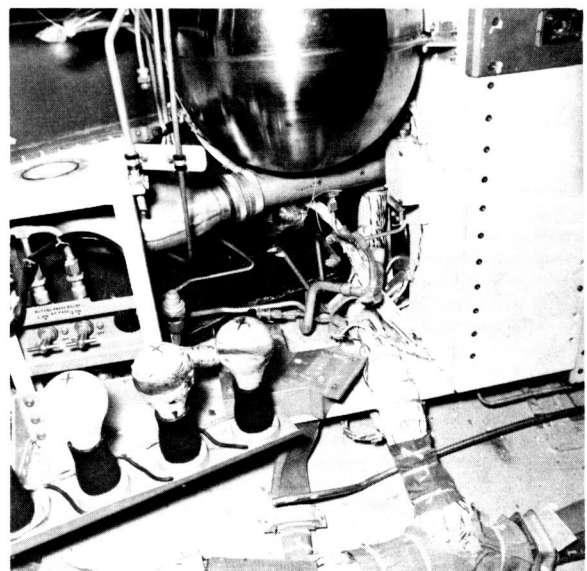
(d)

sidewall, which caused the equipment shelves to deflect under their own weight approximately 2 inches. Although extensive damage occurred on the sidewall in the oxygen surge tank area (fig. 31(d)), the surge tank was not damaged.

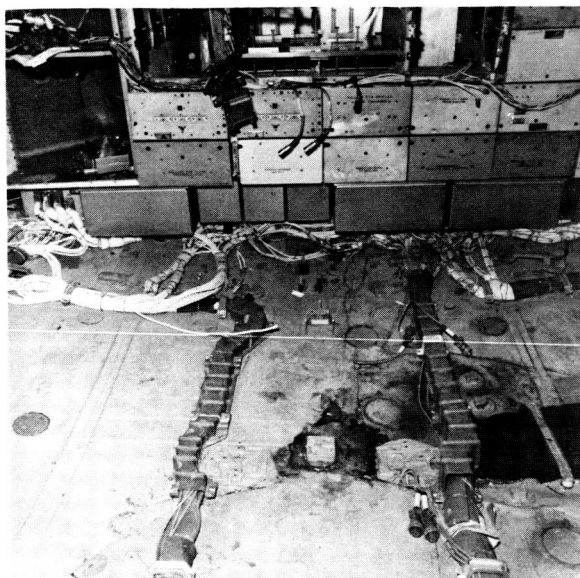
(e)

The aft-bulkhead core failed in shear in an area approximately 6 feet in diameter in the +Z sector, and a crack through both face sheets extended approximately 36 inches from the center in the +Z direction (fig. 31(e)). The oxidizer tanks were crushed, and the fluid from the tanks escaped and entered the crew compartment through the crack in the aft bulkhead. The aft bulkhead was separated from the crew-compartment sidewall through an included angle of 196° (fig. 31(f)).

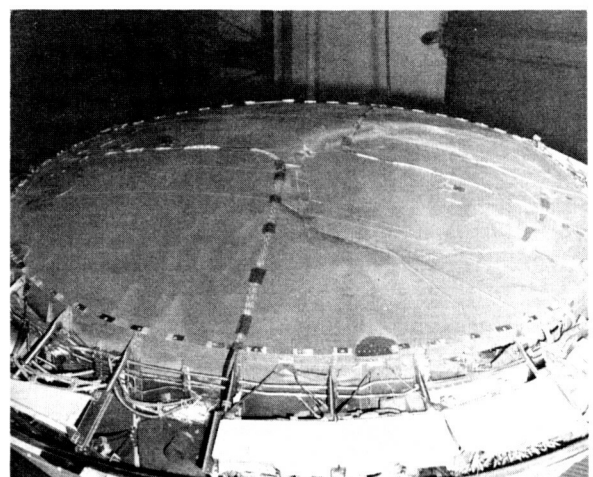
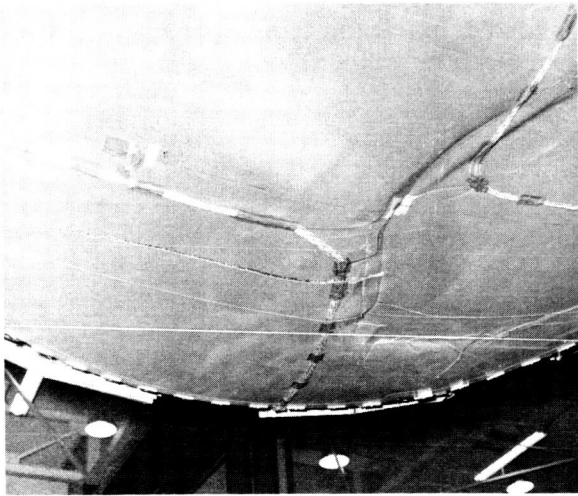
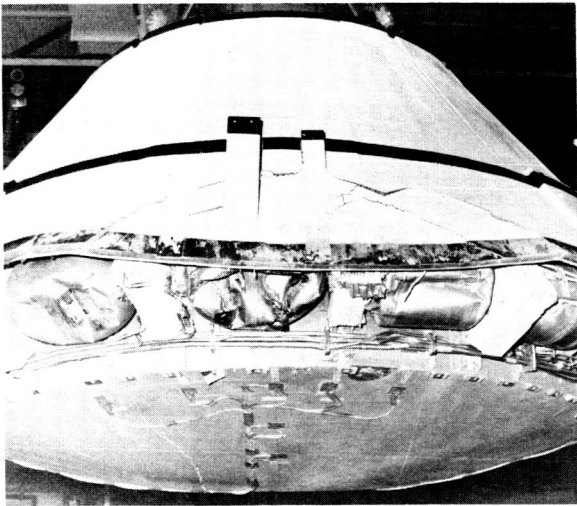
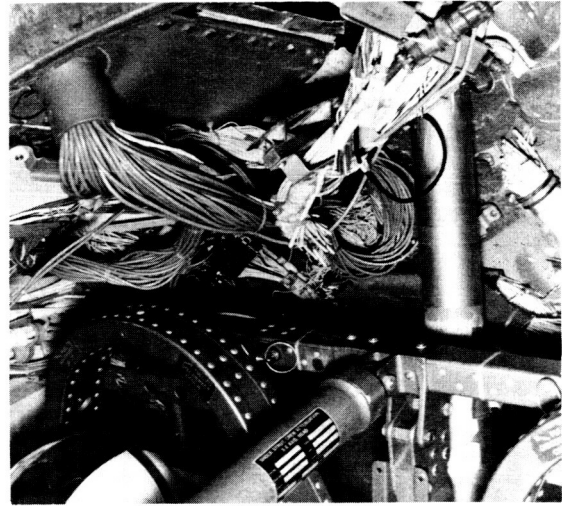
Figure 33. - Impact damage to CM-011.

Test 64 with CM-011 was conducted at a horizontal velocity of 54 fps, equivalent to the maximum wind velocity in which the launch vehicle can be operated. The resulting kinematics were even more violent than those of test 63 with CM-009. The second impact of CM-011 occurred at a pitch attitude of approximately 300° and loaded the aft sidewall and heat shield more severely in the X axis direction and less in the Z axis direction than did the test conditions of CM-009. The aft area of CM-011 was damaged to a greater extent than that of CM-009. However, the separation of the aft bulkhead from the aft sidewall was less extensive, occurring throughout a 110° segment of the sidewall. The damage included numerous cracks in the aft bulkhead and sidewall that could permit the passage of toxic fumes and fluids from the aft equipment bay. On second impact, the sidewall beneath the crew hatch was crushed inward and upward from 12 to 18 inches, which fully compressed the Z-Z struts of the crew couch and produced high accelerations in the crew-couch system. The kinematics of the CM-011 test are shown in figure 32, and typical damage is pictured in figure 33.

Another potential crew hazard was revealed during the test of CM-011 when the Z-Z couch struts stroked to their limit in compression as a result of the crushing of the -Z sidewall of the spacecraft. The crew couch was loaded severely and caused the Z axis accelerometer in the chest of the center dummy to record 37.5g. Subsequent modifications of the Z-Z strut design have further reduced their stroking load, which will provide even less protection from stroking to their limit during severe 180° roll landings.

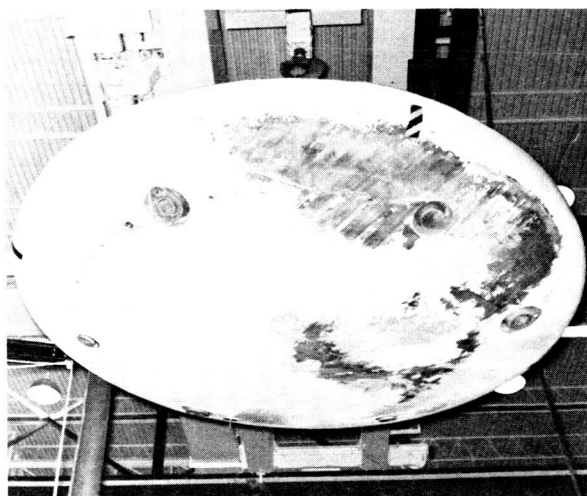
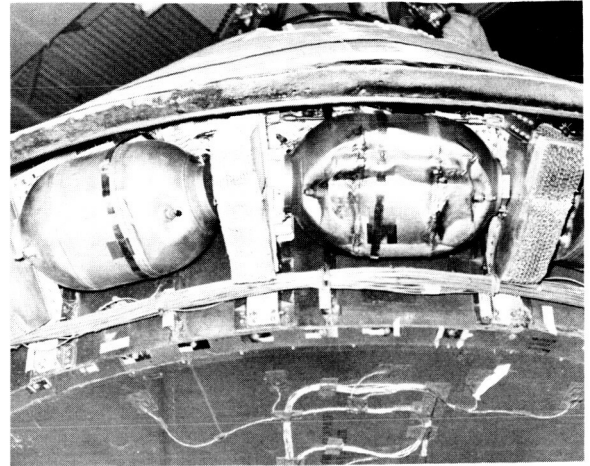
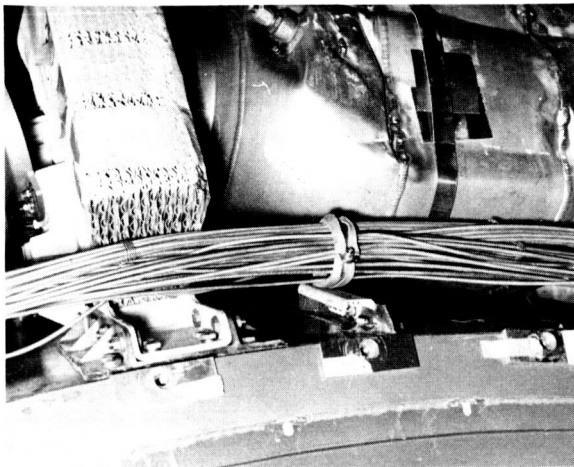
Figure 43. - Damage to CM-002B in test 68.

Less damage was sustained by CM-002B than by any other spacecraft tested in the program (fig. 43). Damage was limited primarily to the +Z section of the aft heat shield where some slight buckling occurred outside the bolt circle. No damage was apparent on the crew-compartment aft bulkhead. A slight debonding of one sidewall frame occurred.

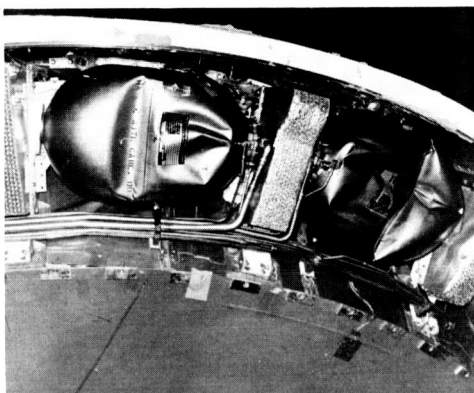
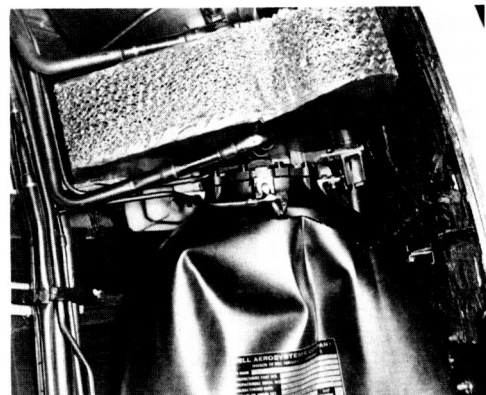
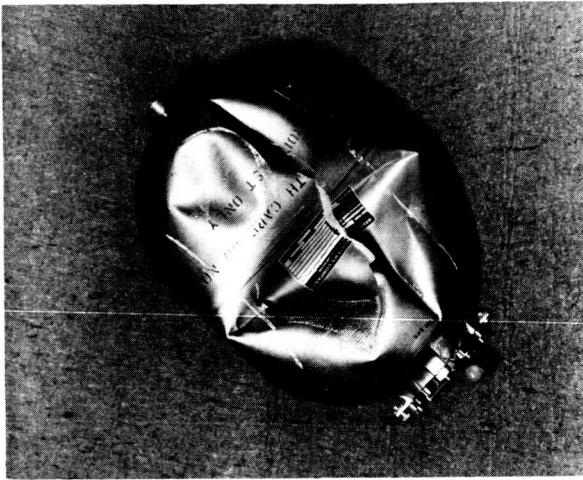
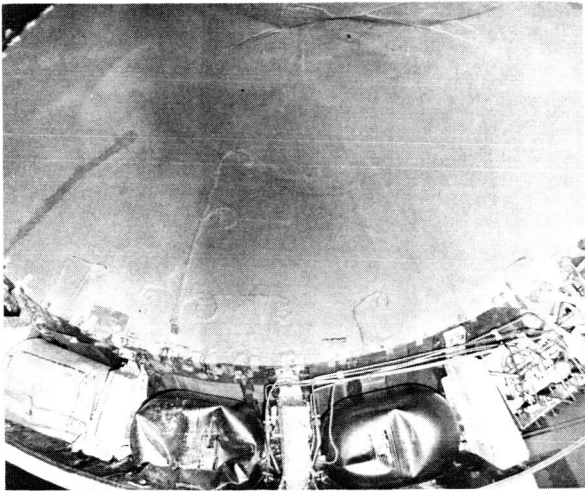
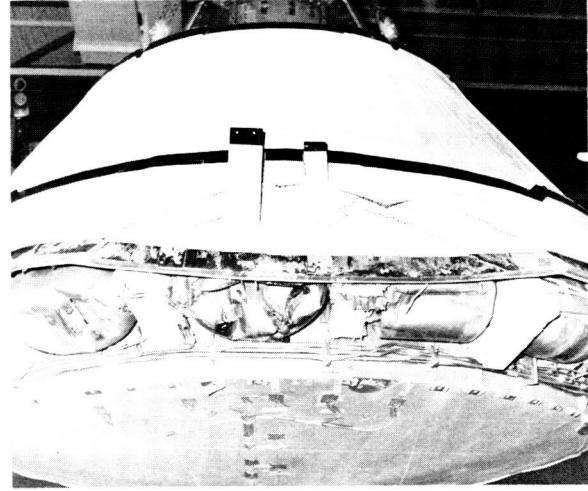
Figure 44. - Typical impact damage to RCS tanks.

The most probable cause of damage to the tanks is a puncture by the heat-shield ballast plates when the aft area deforms on impact. The ballast-plate installation is slightly different in each spacecraft depending on the extent to which the center of gravity must be adjusted. The locations of the RCS tanks in the spacecraft and the typical clearance between the tanks and the ballast are shown in figure 11.

The RCS tanks. - One or both RCS oxidizer tanks were crushed or ruptured by the aft-heat-shield ballast during all of the spacecraft-impact tests except test 68 with CM-002B. However, none of the fuel tanks

was crushed to such an extent that spillage of the fluid was imminent. Nothing can be concluded about the possibility of a fire resulting from the rupture of the RCS plumbing. Neither this plumbing nor the type of ballast that is most likely to damage this system (fig. 11) were installed on any of the test vehicles. However, extensive damage in areas containing plumbing is indicative of a high probability of toxic-fume release from the oxidizer tanks and a significant possibility of fire caused by the mixing of oxidizer with the fuel from ruptured lines. In most tests, numerous cracks in the aft bulkhead and sidewall provided routes to the crew compartment for the released fluids and fumes. Typical damage caused to RCS tanks by a land impact is shown in figure 44
